SCREENING SITE INSPECTION REPORT
FOR

FAIRMONT RAILWAY MOTORS
FAIRMONT, MINNESOTA
U.S. EPA ID: MND096488986
SS ID: NONE
TDD: F05-8710-005
PAN: FMN0200SB

AUGUST 1, 1989

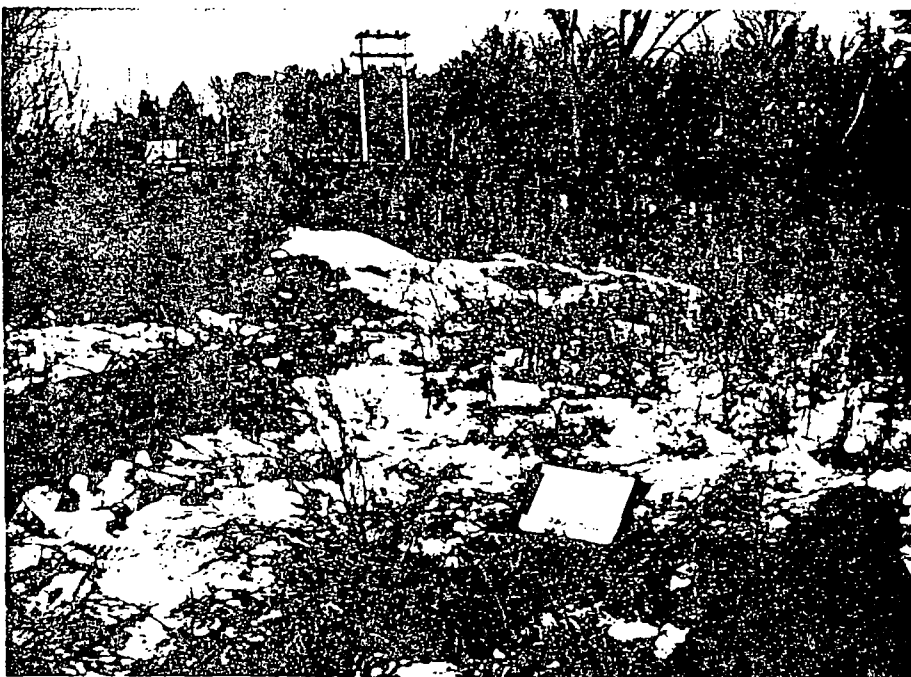
> S1

DESCRIPTION: > Location is about 40 feet south of northern-most set
> of R.R. tracks, near RR bridge that spans waterway between
Lake George and Lake Sisseton.

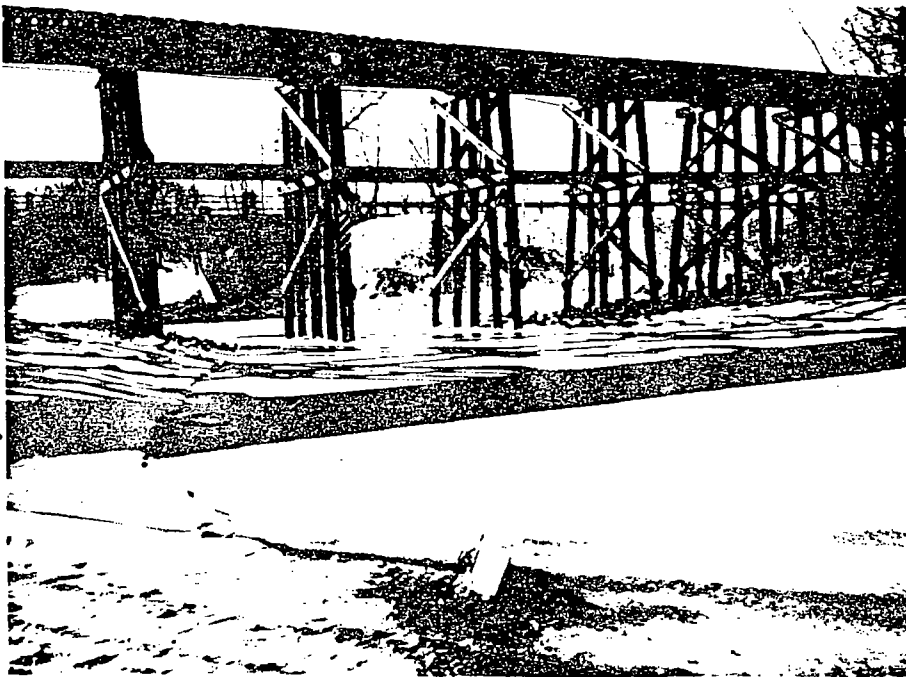
> S2

DESCRIPTION: > Location is about 5 feet from eastern shoreline of channel
> that connects Lake George and Lake Sisseton, between the
northernmost and southernmost R.R. bridges, 20 ft. south of north bridge.

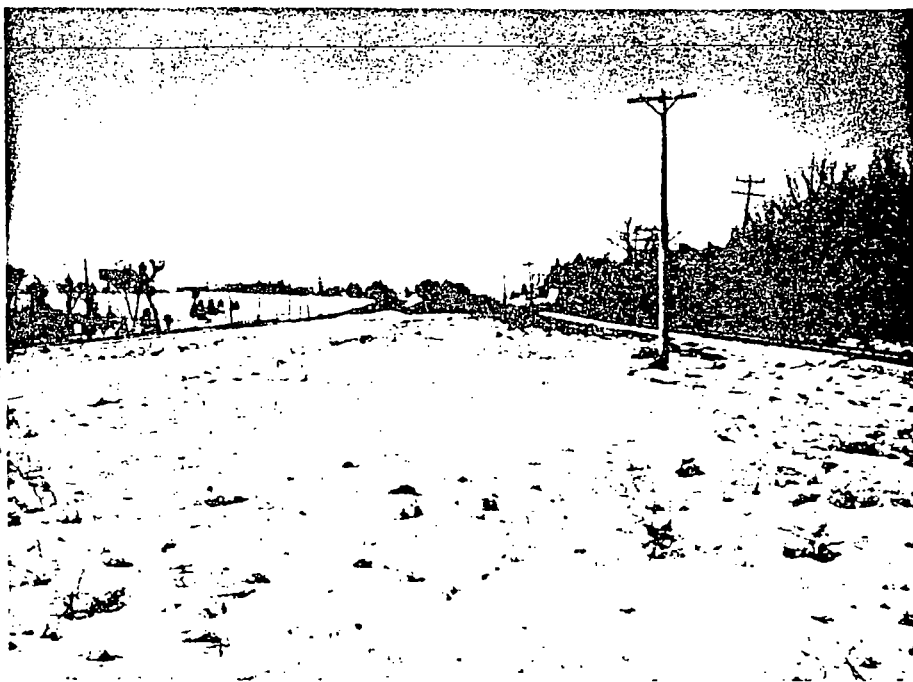
DESCRIPTION: > Photo taken from 4th ave. facing west over
> fill area between north + south sets of R.R. tracks.

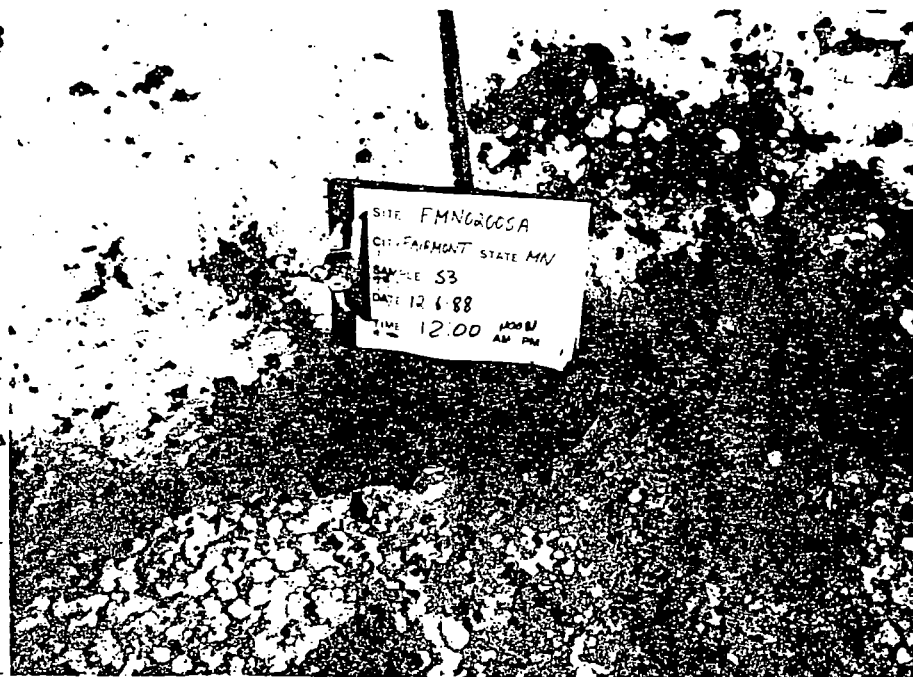
DESCRIPTION: > Hole in ice through which sediment sample "S3"
> was collected.

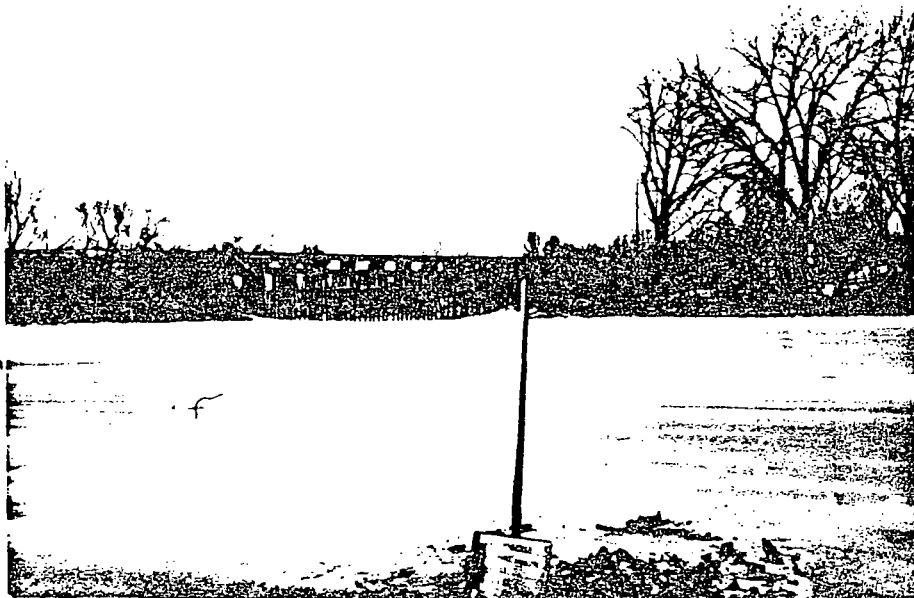
> S3

DESCRIPTION: > Placard for sediment sample "S3" in foreground with

> view to south of twin RR bridges spanning the waterway between
Lake George and Sisseton Lake. "S3" taken 10 ft. from shoreline.

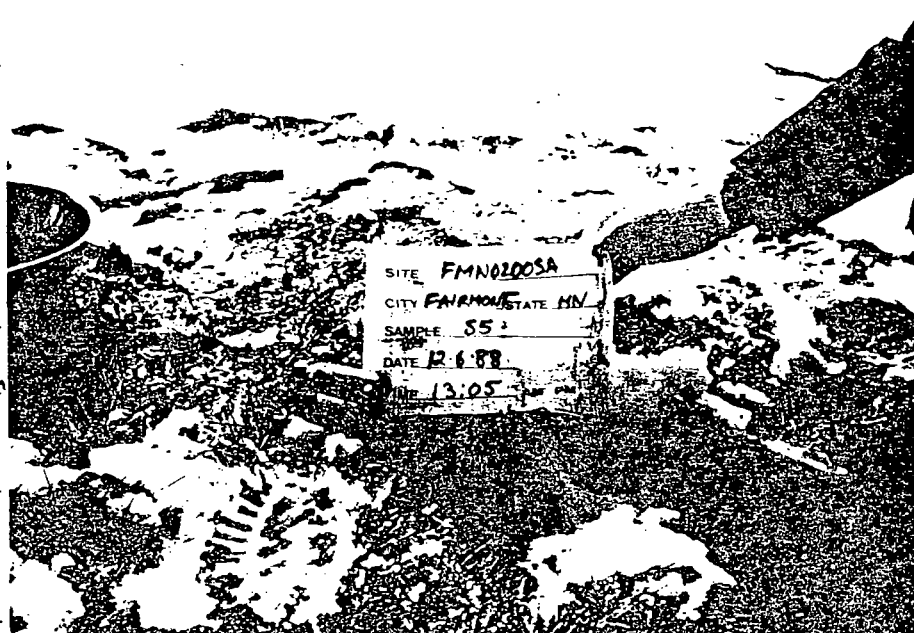
> S5

DESCRIPTION: > Soil sample S5 taken in Lincoln park as a background

> sample.

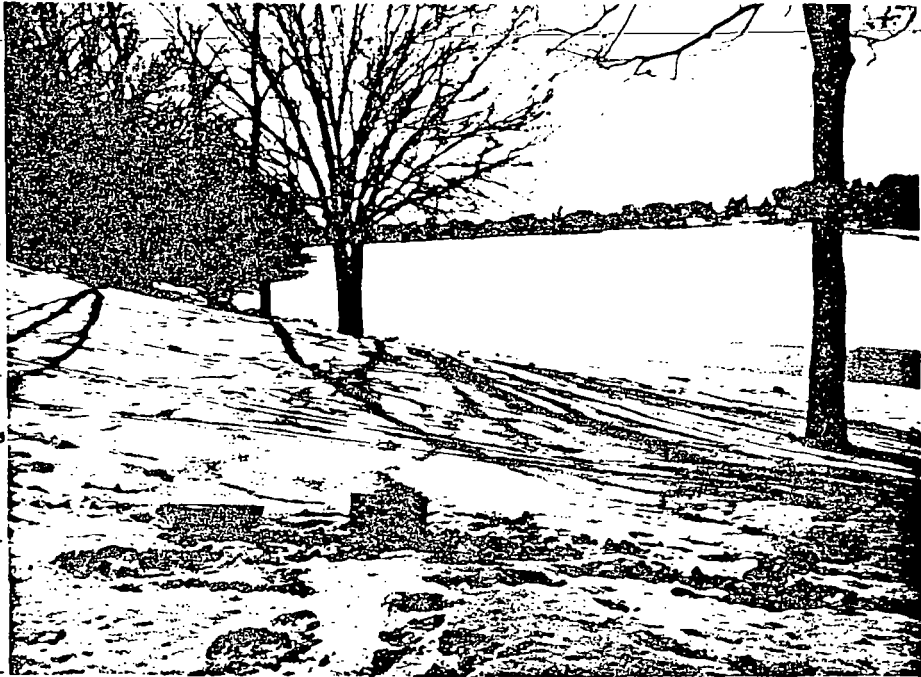
DESCRIPTION: > Soil sample "S5" location at placard with Lake

> George in background. Sample taken about midslope (20% slope) in Lincoln Park.

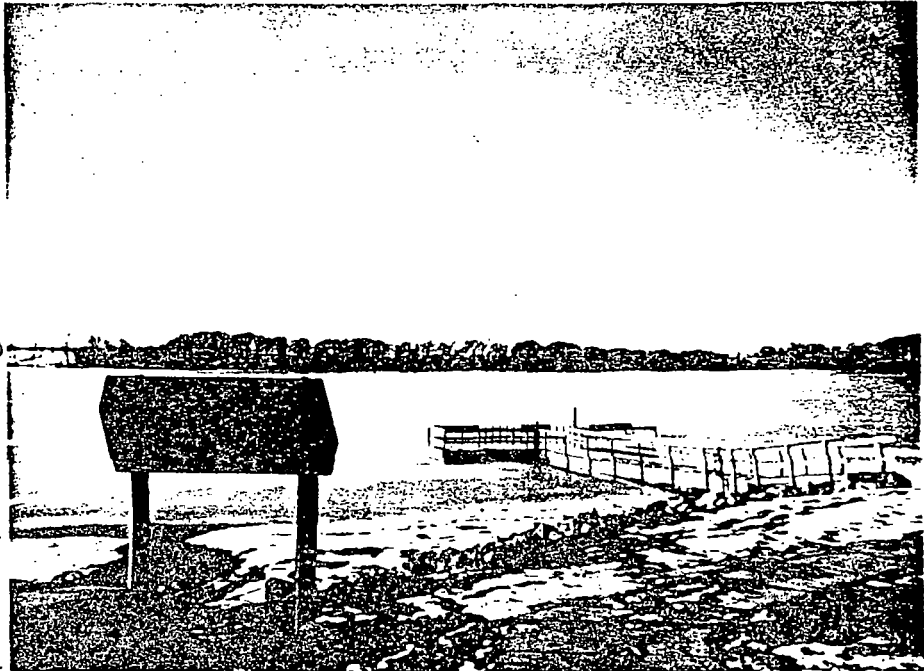
DESCRIPTION: > Point used as access location for off-site sediment

> Sample "S6". Facing west over Sisseton Lake Fishing Pier. "S6" was taken just north of this pier about 75 ft.

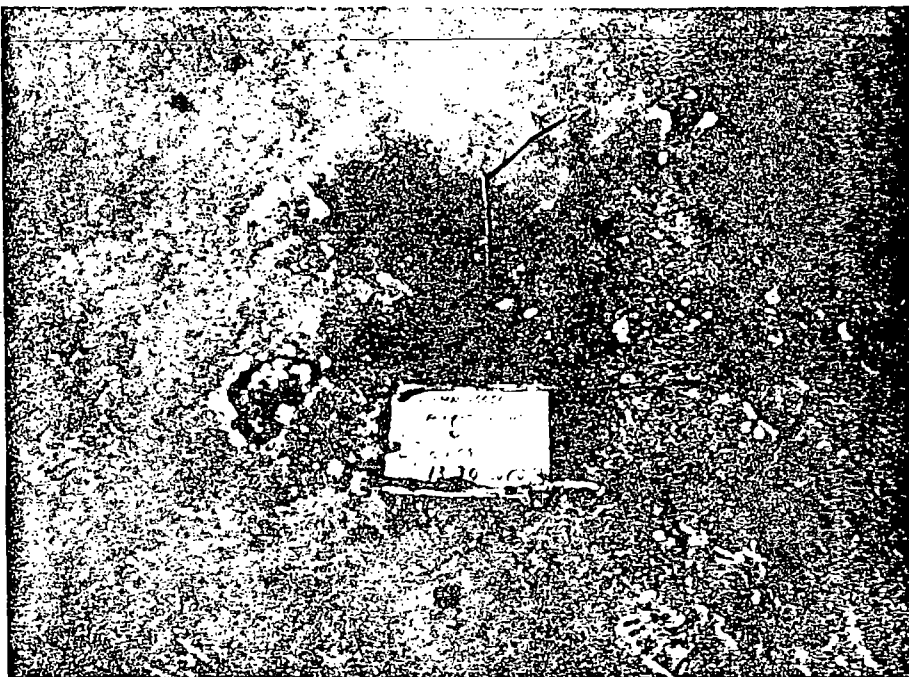
> 56

DESCRIPTION: > Hole in Sisseton Lake ice cover through which
> background sediment sample "56" was taken. Located about
75 ft. North of Sisseton Lake fishing pier, 5-10 ft. from shore.

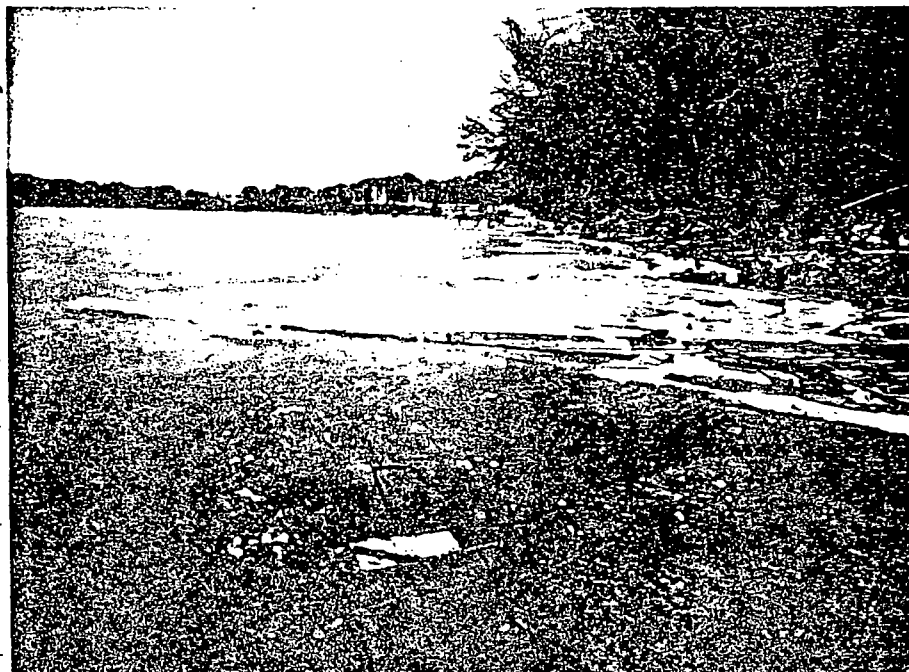
> 56

DESCRIPTION: > Facing north over sample location "56", along
> Sisseton Lake shoreline.

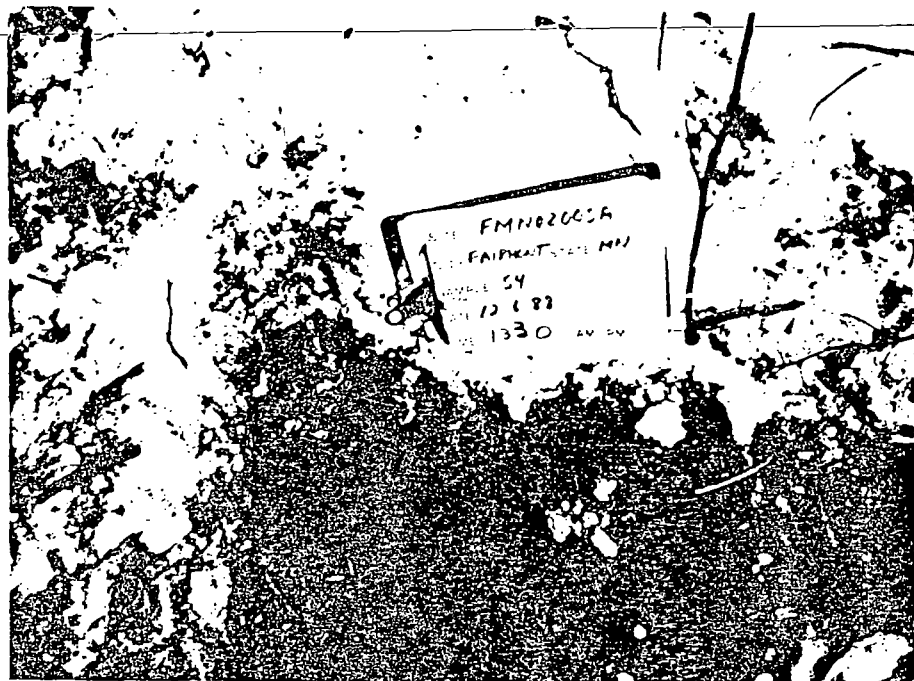
> 84

DESCRIPTION: > Closeup of 84 soil sample

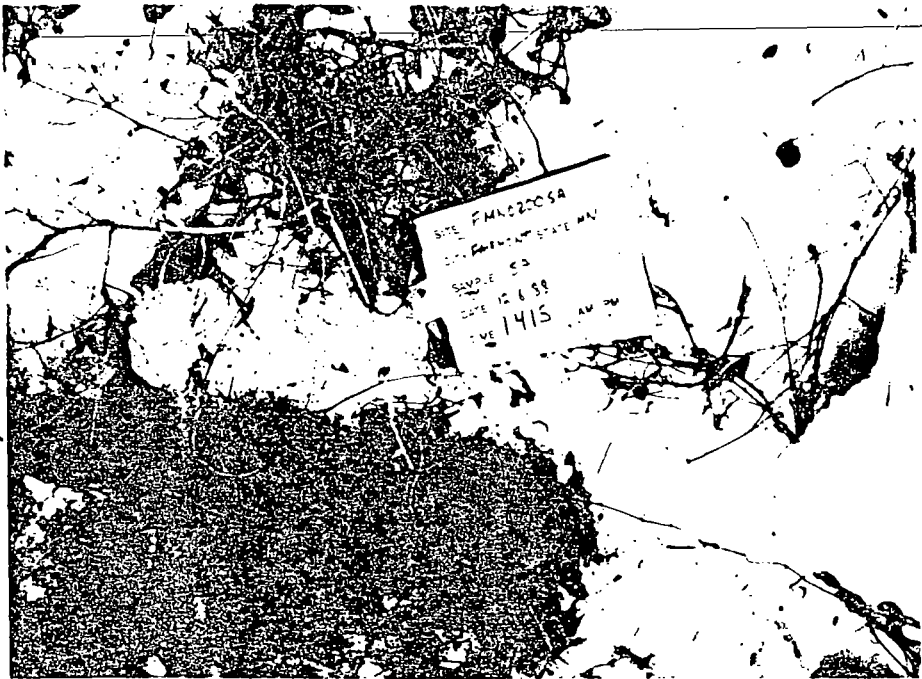
> 57

DESCRIPTION: > Closeup of "57" soil sample.

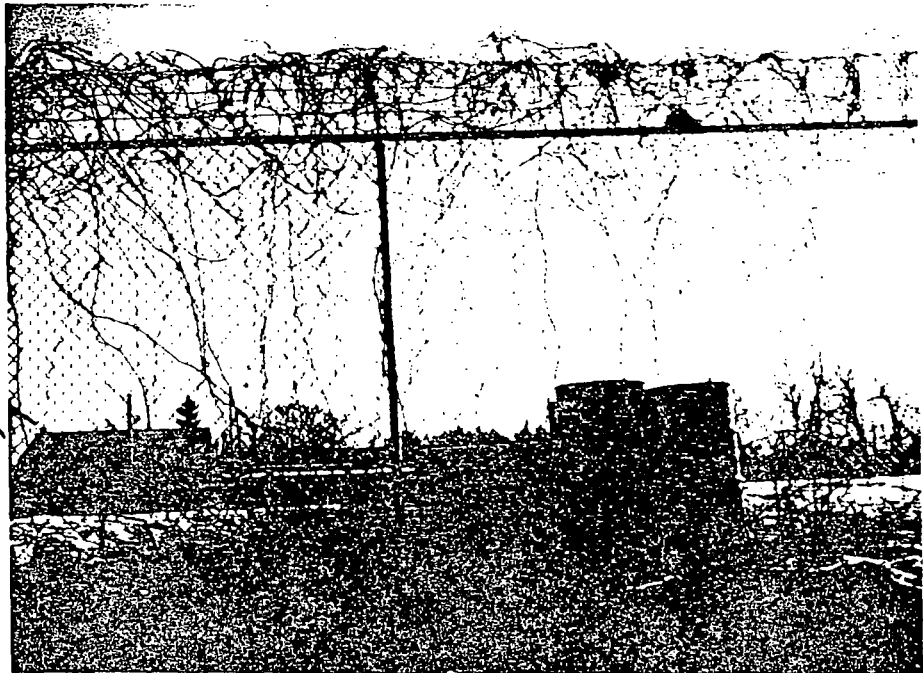
> 57

DESCRIPTION: > Photo taken from north-most R.R. track showing
> perspective of soil sample 57.

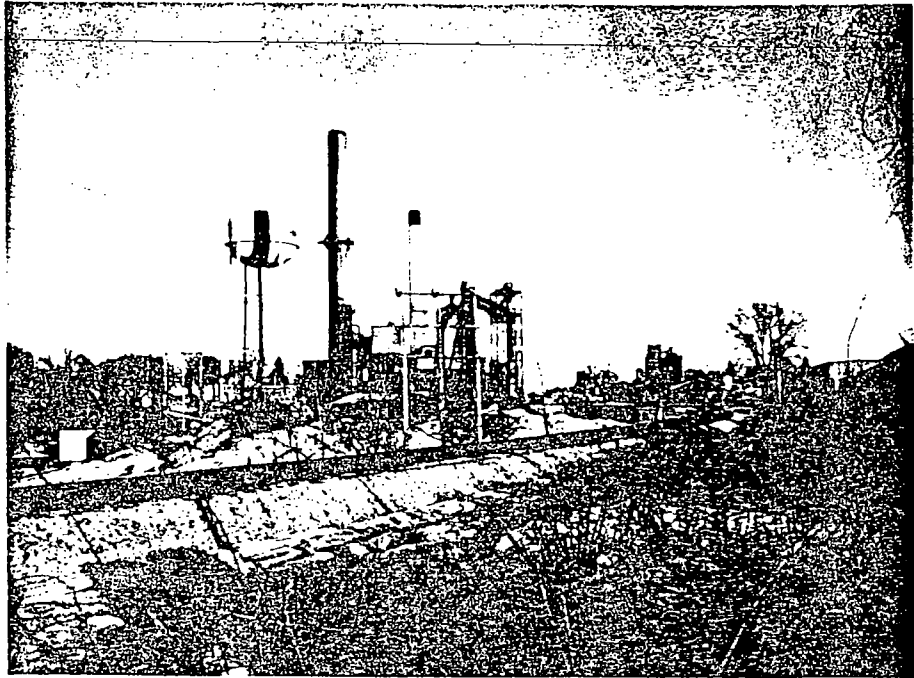
> 57

DESCRIPTION: > Perspective of "57" with power plant in
> background.

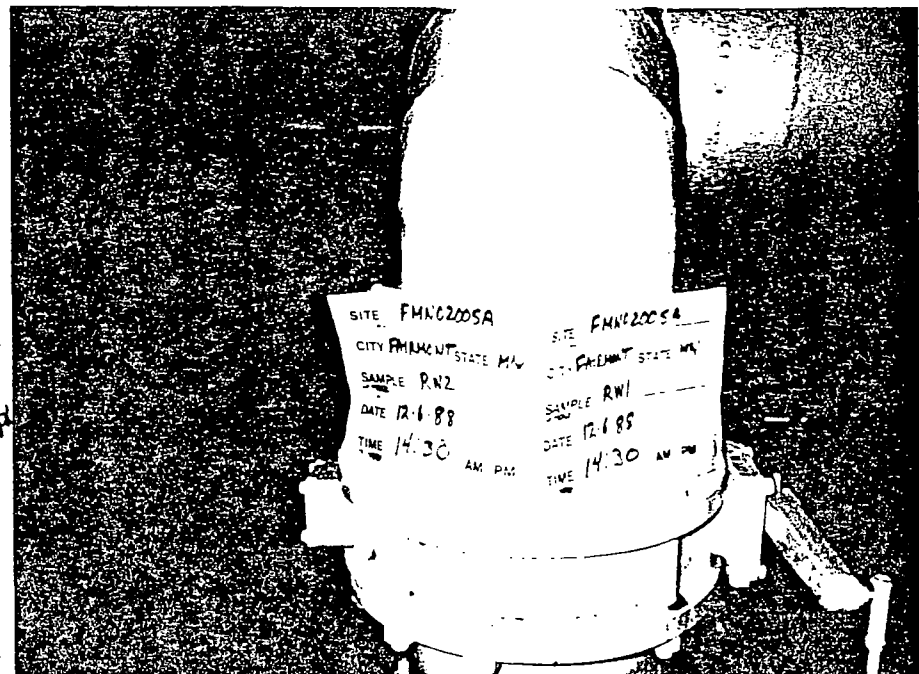
> RW1 + RW2

DESCRIPTION: > RW1 and RW2 (duplicate) taken from this
> access point in the City's (Fairmont, MN) municipal water
department building on Athol Street.

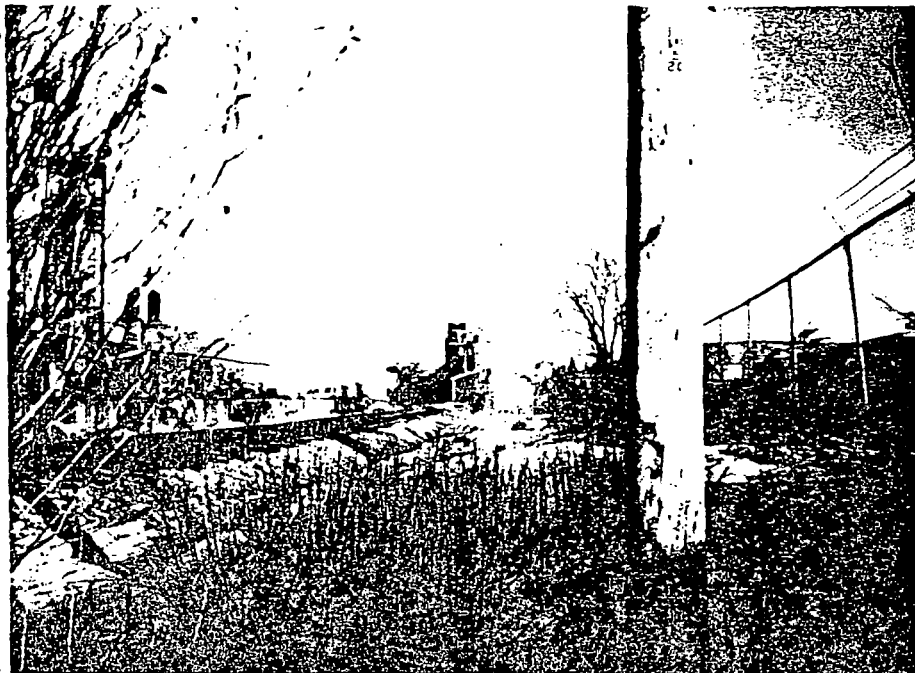
> 58

DESCRIPTION: > Perspective of "58".

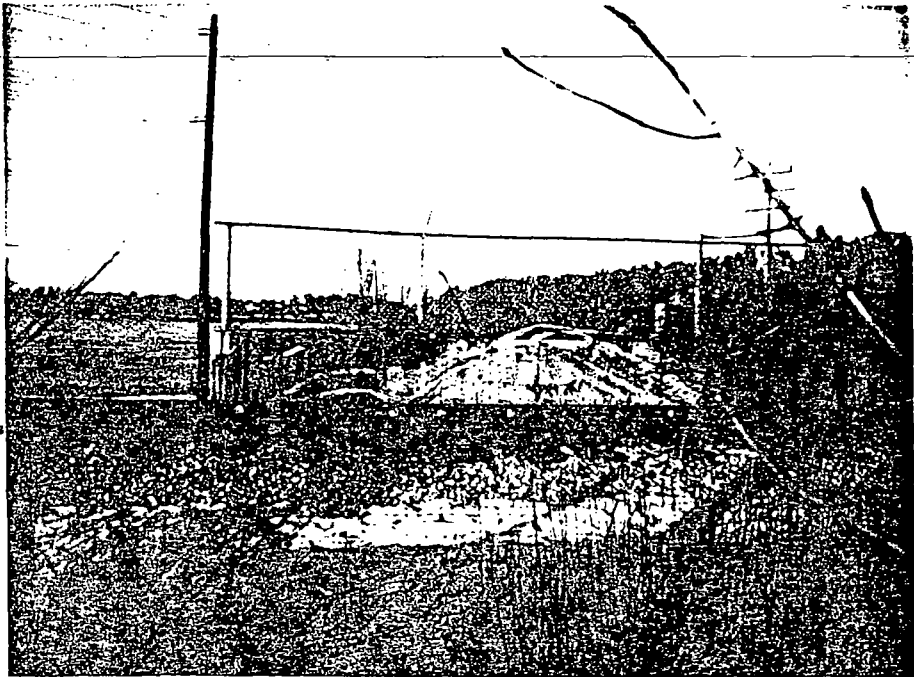
> S8

DESCRIPTION: > Northward perspective of "S8", Coal pile
> for IL Power Co. with George Lake in background.

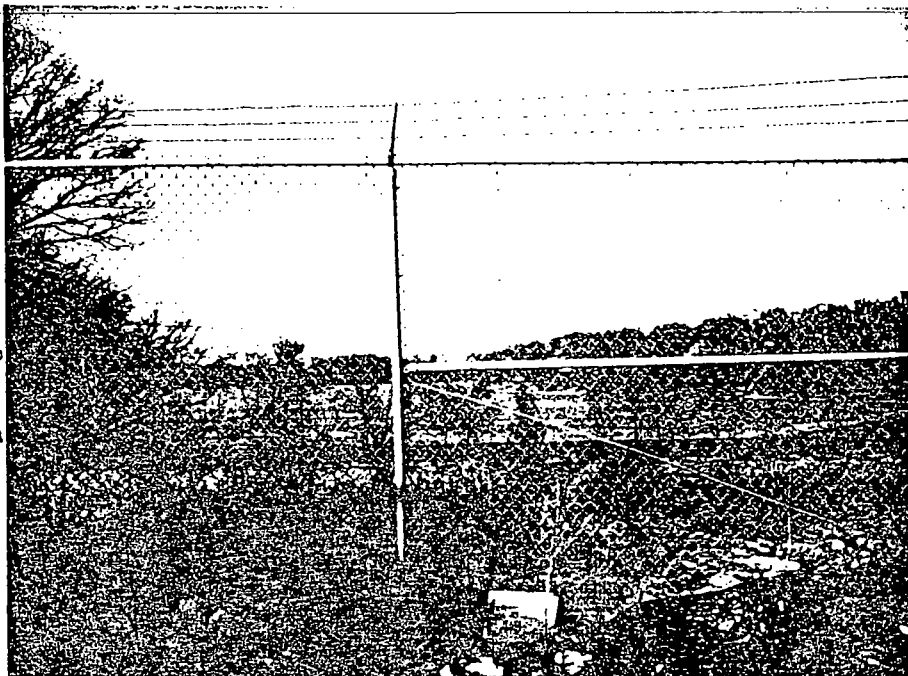
> S9

DESCRIPTION: > Perspective of "S9" facing North over RR. tracks
> and Lake George.

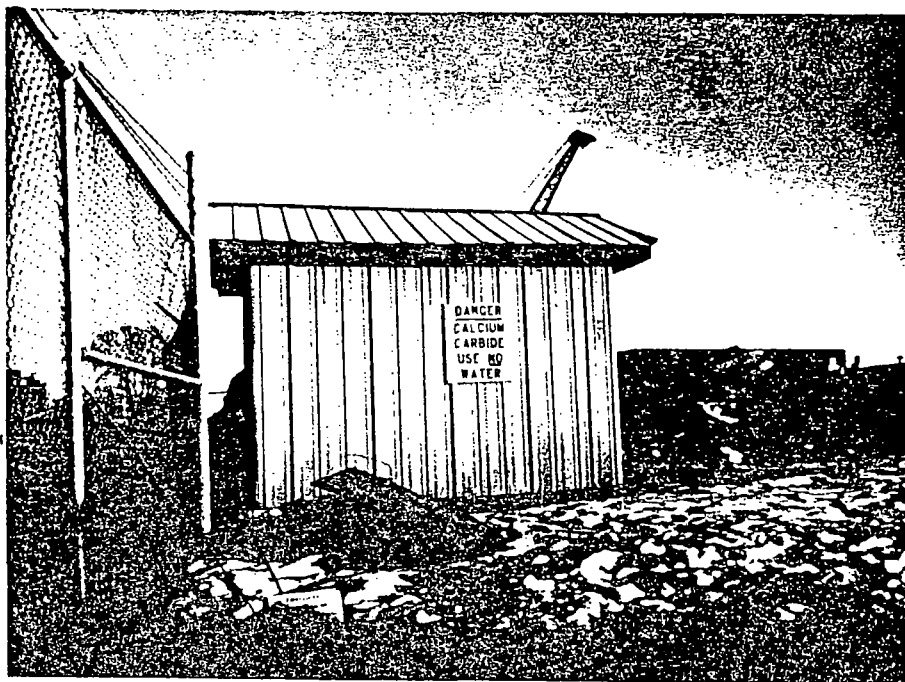
> S9

DESCRIPTION: > Perspective of "S9" facing East along
> northern property boundary. Metal shavings/cuttings
on right. This is on top of previously filled area.

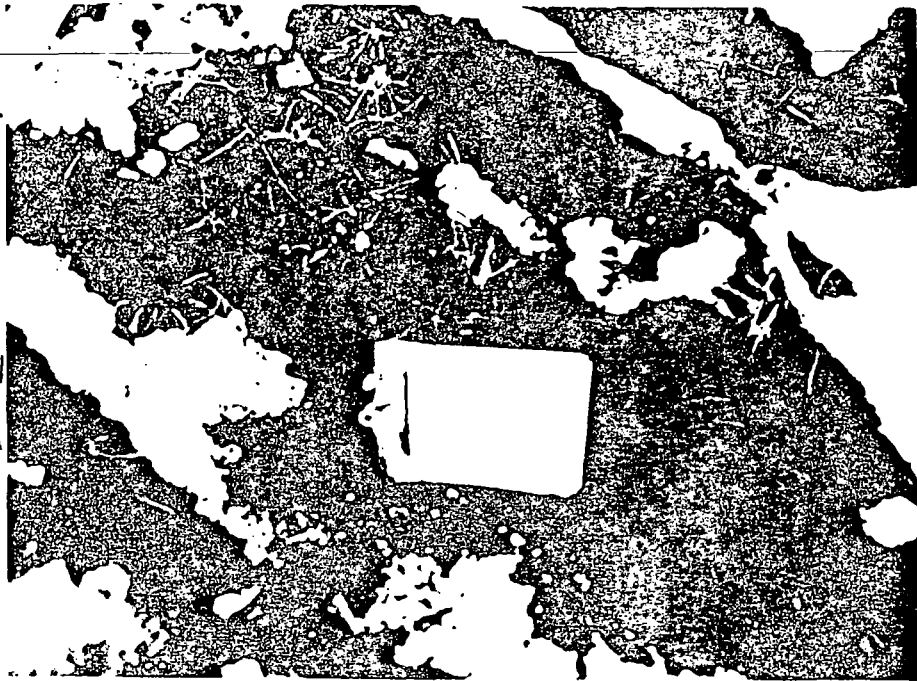
> S10

DESCRIPTION: > Closeup of "S10" soil sample.

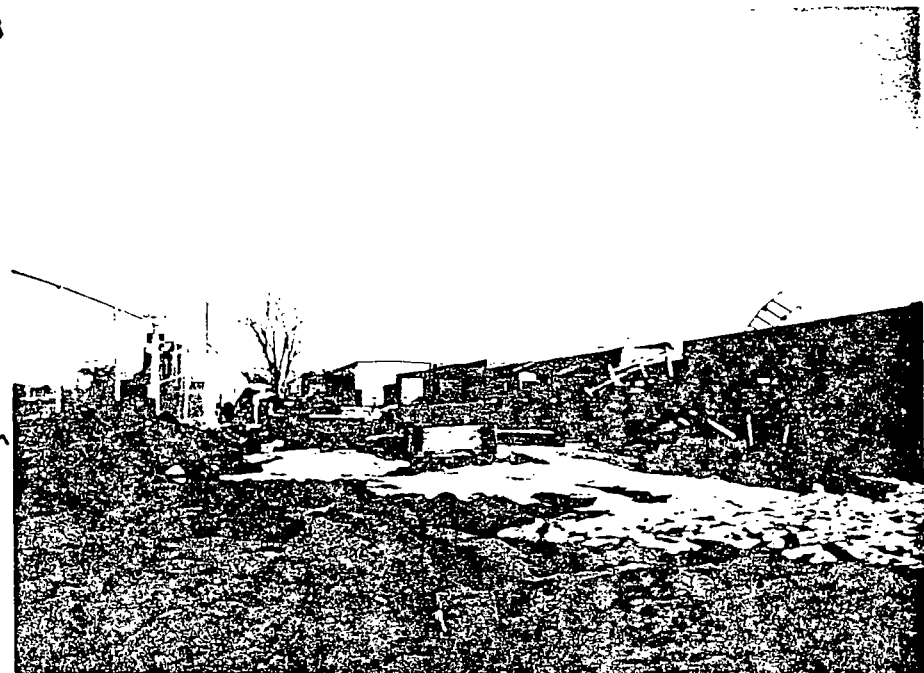
> S10

DESCRIPTION: > Perspective of "S10" facing East. Note
> metal scrap. This area is on top of previously filled
area.

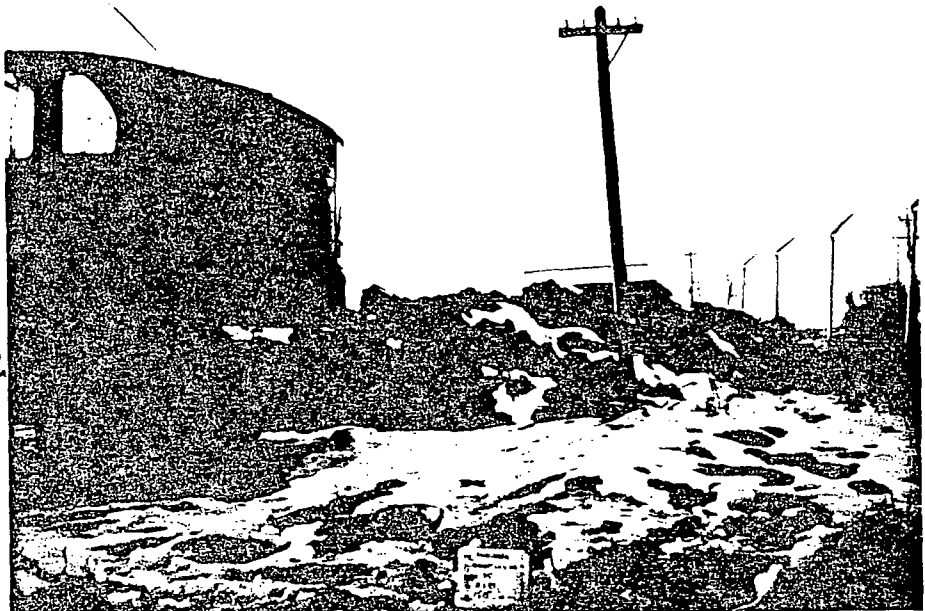
> S10

DESCRIPTION: > Perspective of "S10" facing West. Note

> metal shavings/cuttings stored beyond crane, near pole.
Previously filled area directly below crane.

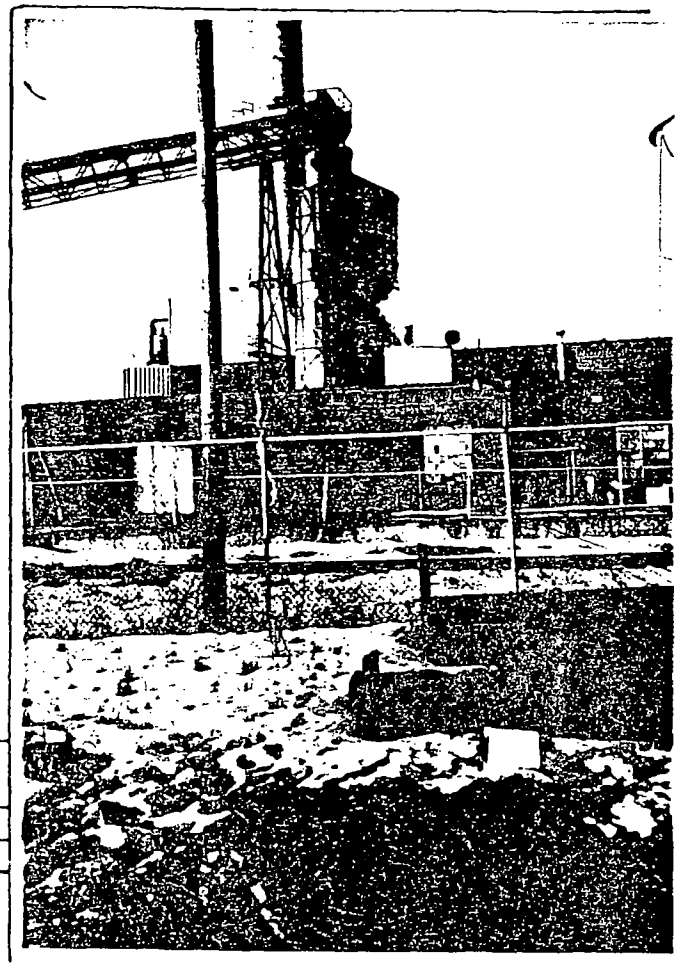
DESCRIPTION: > Perspective of S11

> facing north, Power Co. Metal
beams and scrap metal pile in
foreground.

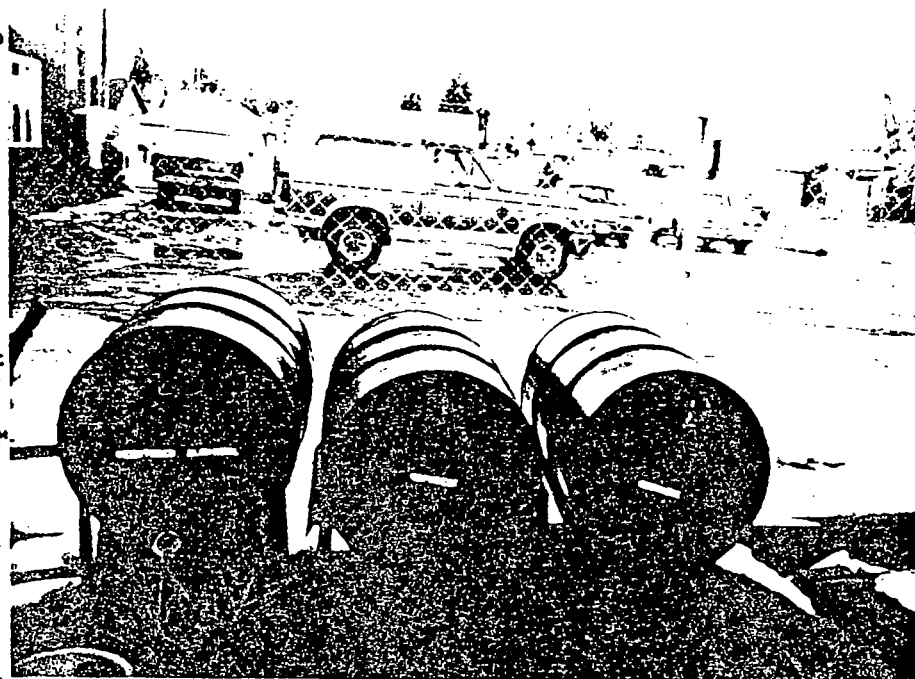
DESCRIPTION: > Drums of Denatured Alcohol & Kerosene along northern
> property boundary.

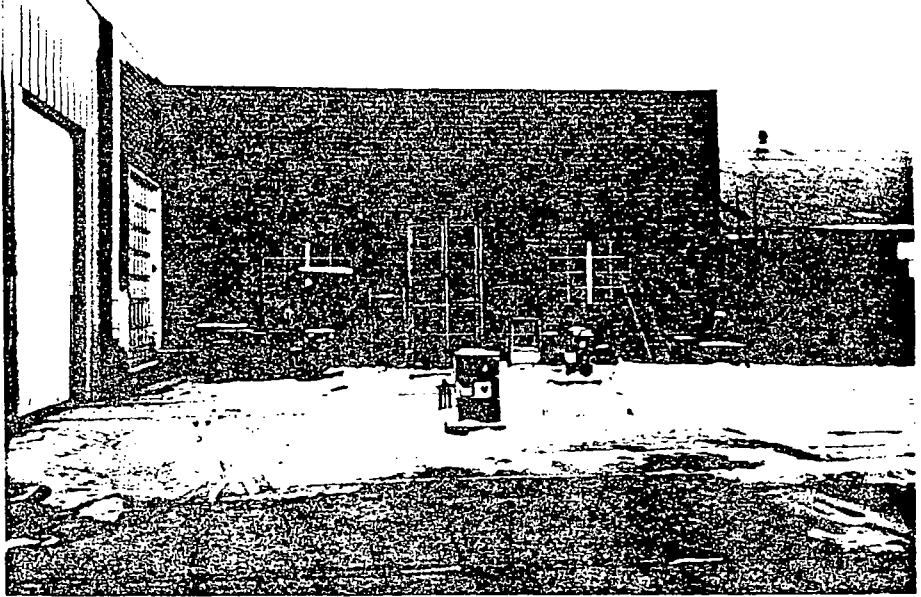
DESCRIPTION: > Fairmont Railway Motors' Main Building taken from
> their northern property boundary, near the East end of plant.

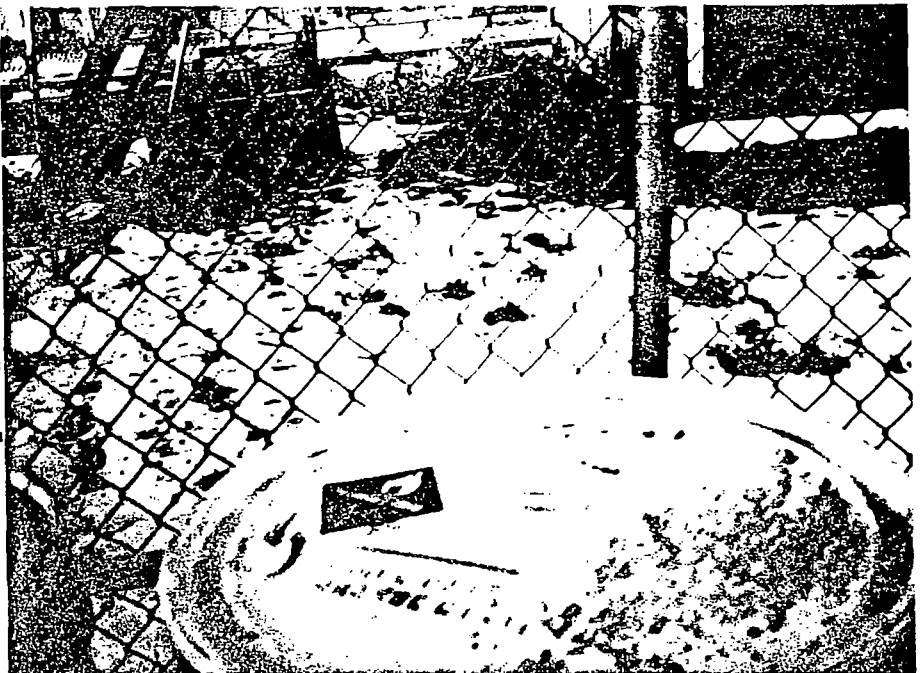
DESCRIPTION: > Flammable material in drain along northern
> property line, just east of S11 about 20 feet.
